Spring has sprung and HTC has hatched a new One. Join us as we take a closer look at this season's newest sprout, the HTC One (M8). After all, it's our job to weed out the irreparable, and the best way to do that is through destruction—er, precise analysis.

Step 1 — HTC One (M8) Teardown

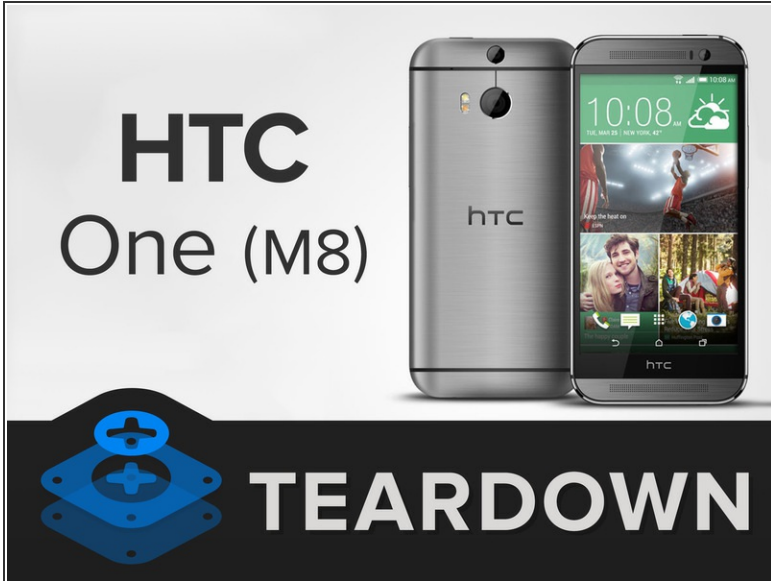
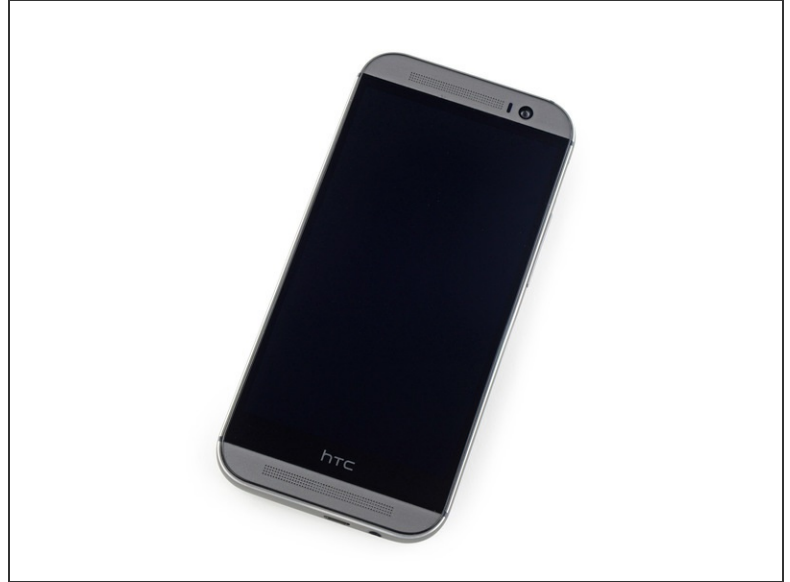
- For its second act, the HTC One brings some impressive props. The lengthy list of hardware includes:
 - Quad-core, 2.3 GHz Qualcomm Snapdragon 801 processor
 - 2 GB RAM
 - 5" 1080p display with dual front-facing speakers
 - 4 MP (2 "ultrapixel") f/2.0 rear Duo Camera with dual flash; 5.0 megapixel front-facing camera
 - 16 or 32 GB on-board storage; up to 128 GB additional storage via microSD
 - LTE, Bluetooth 3.0, NFC, 802.11ac Wi-Fi, and IR blaster
- The immediate question is whether the M8 will prove more cooperative than its [nigh-unreparable predecessor](#), whose hardware secrets had to be pried from its mangled aluminum corpse.

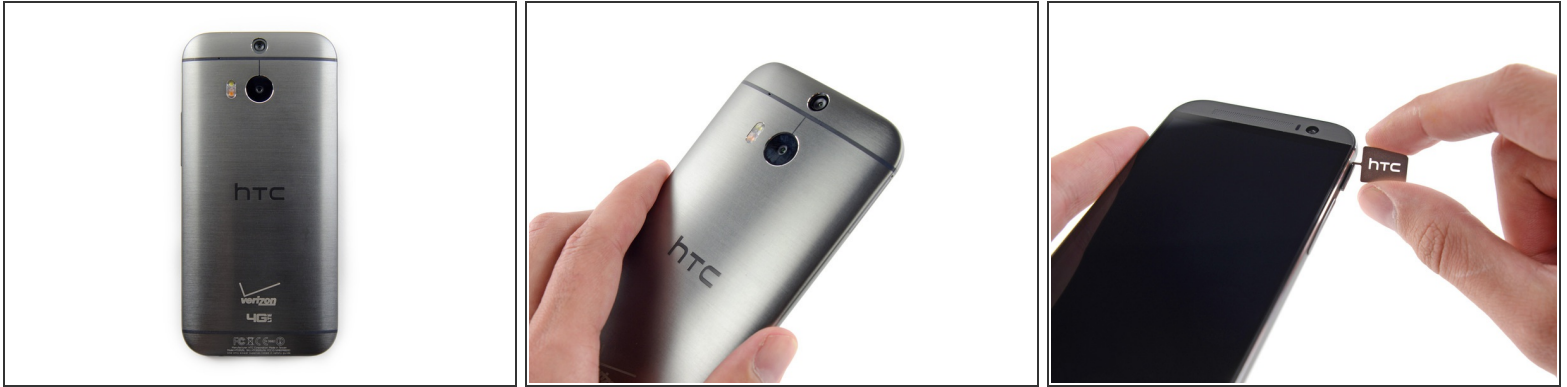
Step 2

- While we ponder our plan of attack, we pause to appreciate the One M8's appealing—albeit inscrutable—brushed metal design.
- Dual rear cameras, dual flash—despite being dubbed the One, this phone [likes its Twos](#).
- Spinning the M8 around, we find the first of another pair—two card trays straddling the upper end of the phone (microSD and SIM).
- Maybe we can just call it the One-Two? No? Moving on...

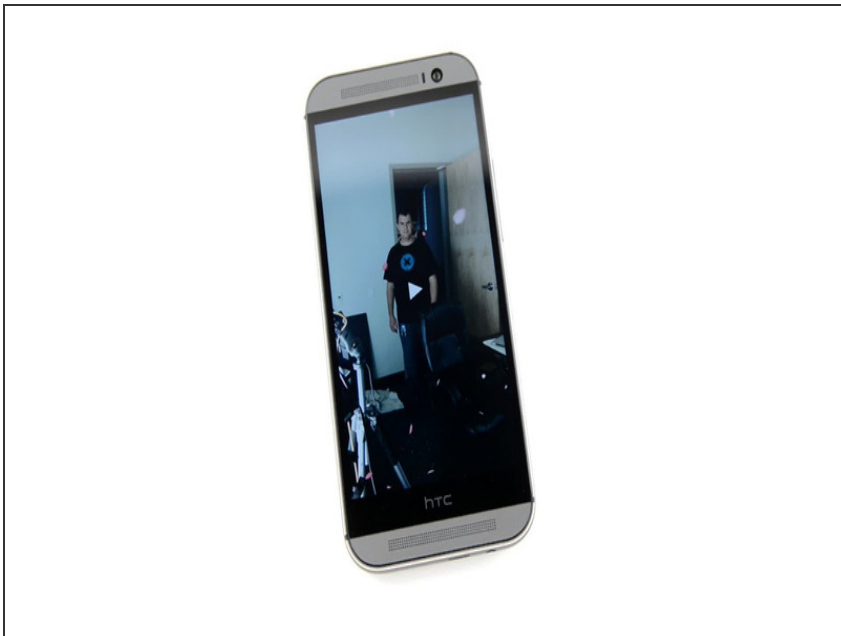
Step 3

- The extra rear camera captures depth information, enabling a host of trick features like *ex post facto* focus adjustments and background removal. We can hardly wait to dig our spudgers in and see how it comes apart.
- ① But first: an homage to [Miro-senpai](#).

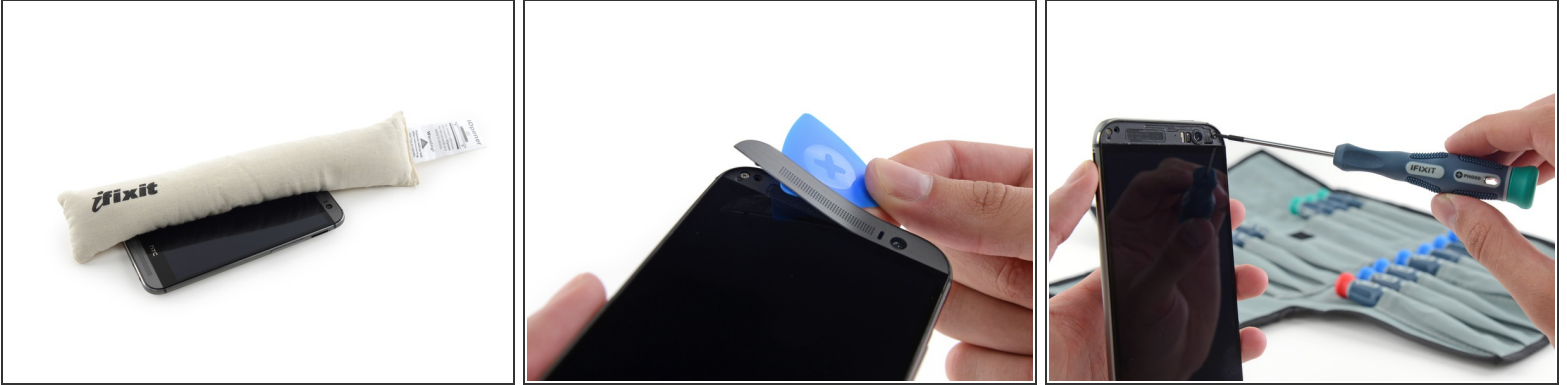
Step 4

- Looking for a point of entry, we surprise the One M8 with a spicy hot [iOpener](#).
- With the underlying glue sufficiently softened, we strum away with a guitar pick until the first screw peeks through.
- ❗ Screws! Glorious screws! Here's the missing link to make this unibody design repairable. Whenever we see [gobs of adhesive and tough clips](#) replaced with screws, we know we're in for a (slightly) happier time.
- Just like that, the One M8's first line of defense is down—with the power of the [Pro Tech Screwdriver Set](#), these screws are deftly dispatched.

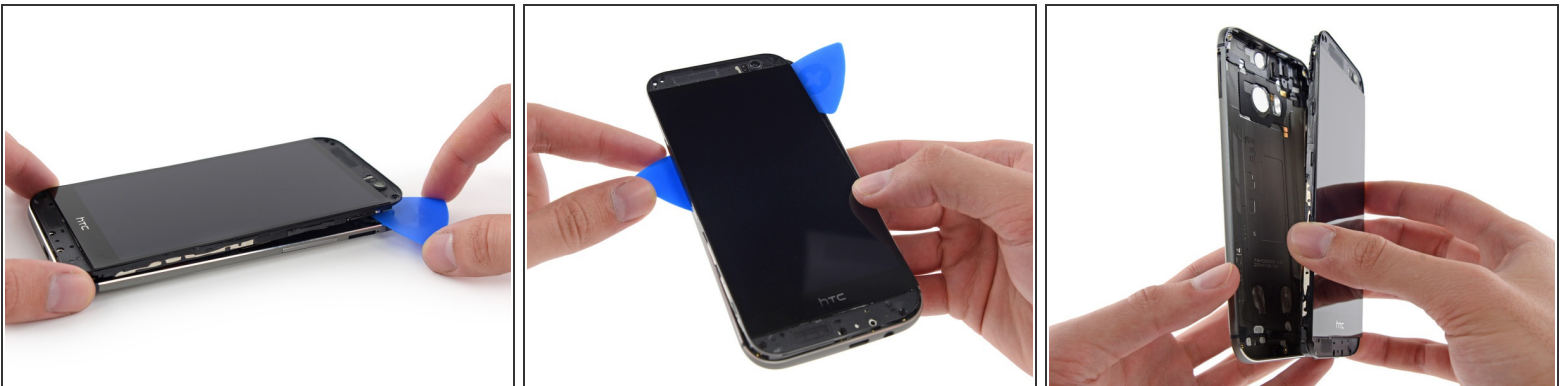
Step 5

- We're on a roll. Gaining momentum, we free the M8's guts from its rear case with the power of rock n' roll [guitar picks](#).
- ❗ We're happy to get this far, but we're not sure this will be a platinum record for repairability. There's only one way to find out: Keep on rockin'.

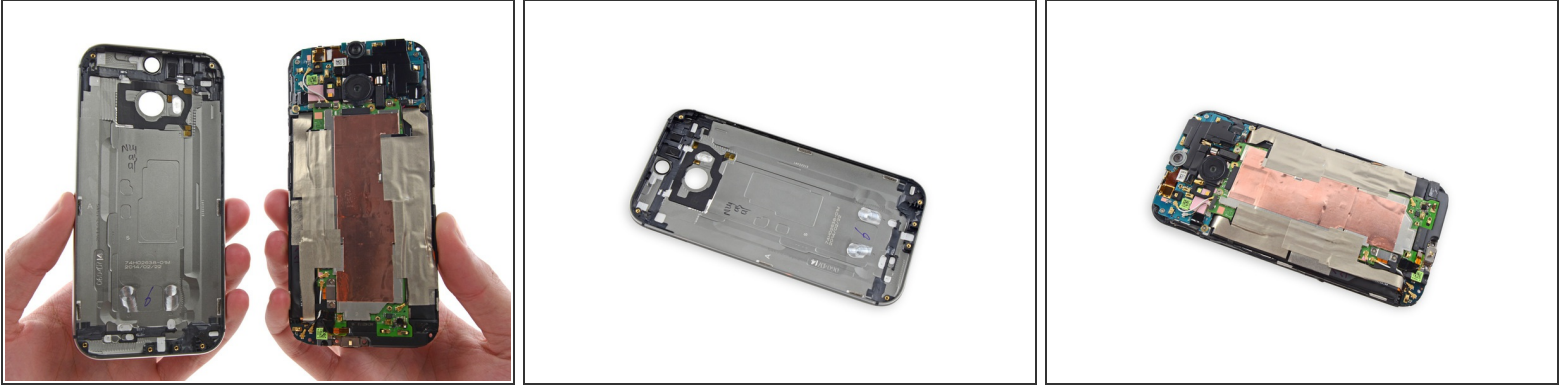
Step 6

- Here's where things turned ugly during our teardown of the first-gen HTC One (the phone that garnered the [all-time worst repairability score](#) of any smartphone we've ever had on the teardown table.)
- To our delight, the pesky display cables of yesteryear have given way to spring contacts—so this time, the phone assembly comes out cleanly.
 - No mangled aluminum here—the rear case remains intact. Apart from the NFC antenna and some nice machine work, there's not much to see.
 - The rear case weighs in at 27.5 grams.
- The remaining assembly is a fair sight less tidy. A mass of copper shielding and tape awaits...

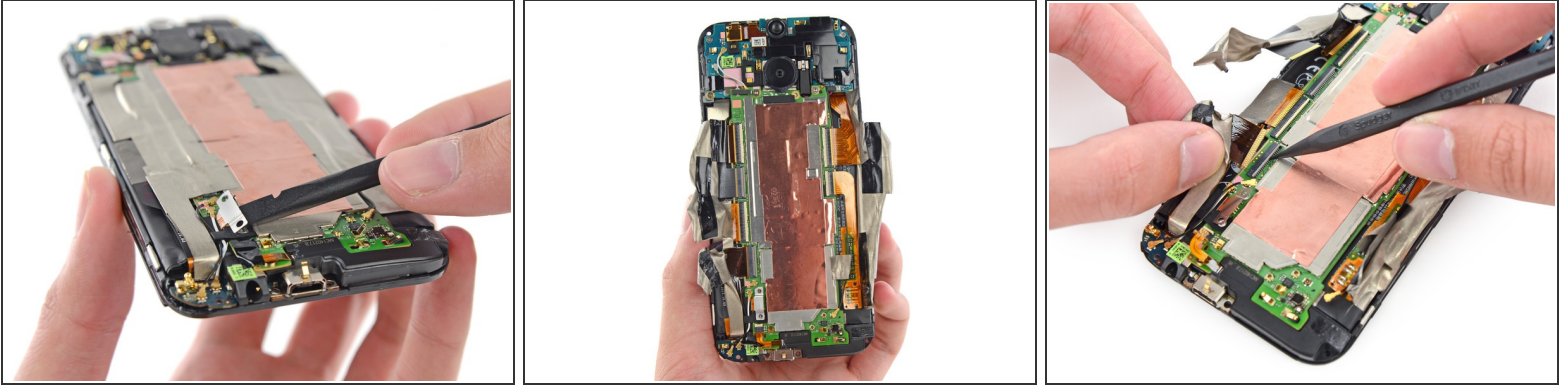
Step 7

- Next, we spudge up the battery connector.

- We start working our way through what looks like aeons of tape strata. Digging through the entire Earth's supply of tape feels a little like a chest burster emerging from a ribcage.
- We're free! Well, except for the billion cables yet to be disconnected.

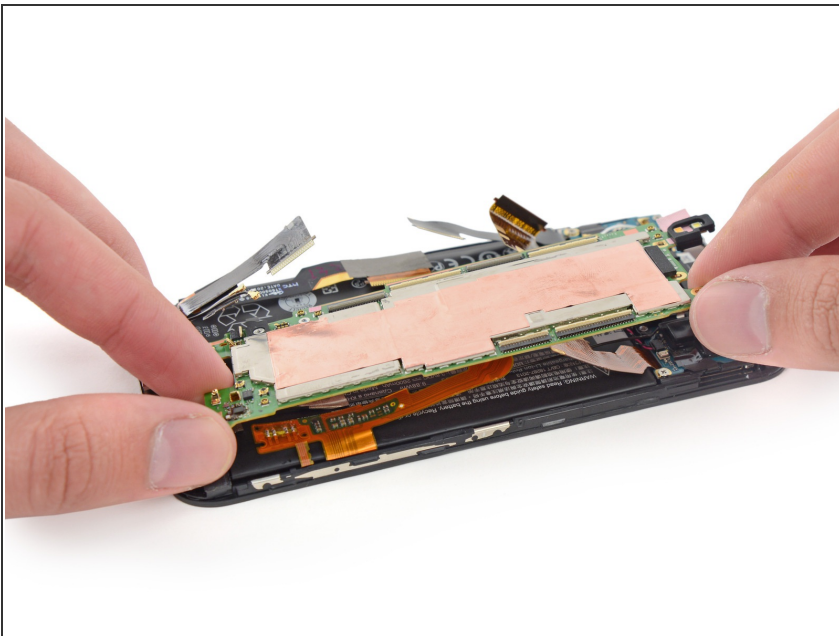
Step 8

- If the rear case removal sparked our hopes for an improved repairability score, this glued-down motherboard is a [bad sign](#).
- [To improve is to change; to perfect is to change often](#). From a repairability standpoint, we'd like to see more change from this One.

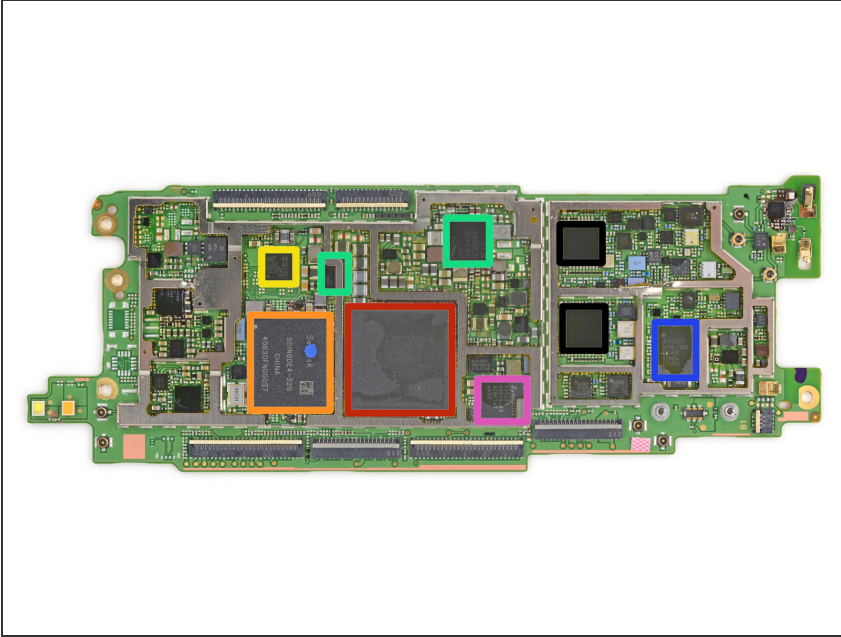
Step 9

- The shields are down! Here's what we found lurking below:
- Elpida FA164A2PM 2 GB RAM + Qualcomm Snapdragon 801 quad-core 2.3 GHz CPU
- SanDisk SDIN8DE4 32 GB NAND flash memory
- STMicroelectronics 0100 AA 9058401 MYS
- Qualcomm [PM8941](#) and [PM8841](#) power management ICs
- Avago [ACPM-7600](#) power amplifier module
- Synaptics S3528A touchscreen controller
- Qualcomm [WTR1625L](#) RF transceiver and WTR1625 (modem?)

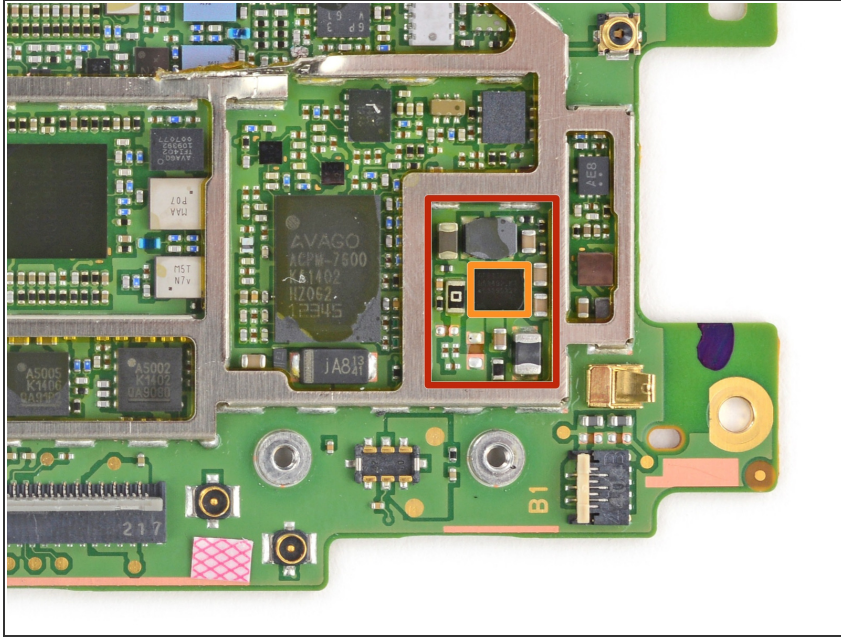
Step 10

- A close up of the RF front end, highlighting the Qualcomm ET subsystem. That's "Envelope Tracking", not "ExtraTerrestrial".
- Inside the red line is the Qualcomm QFE1100 ET IC, plus all the associated passives, weighing in at around 50mm² for the whole footprint.
- The QFE1100 ETIC itself

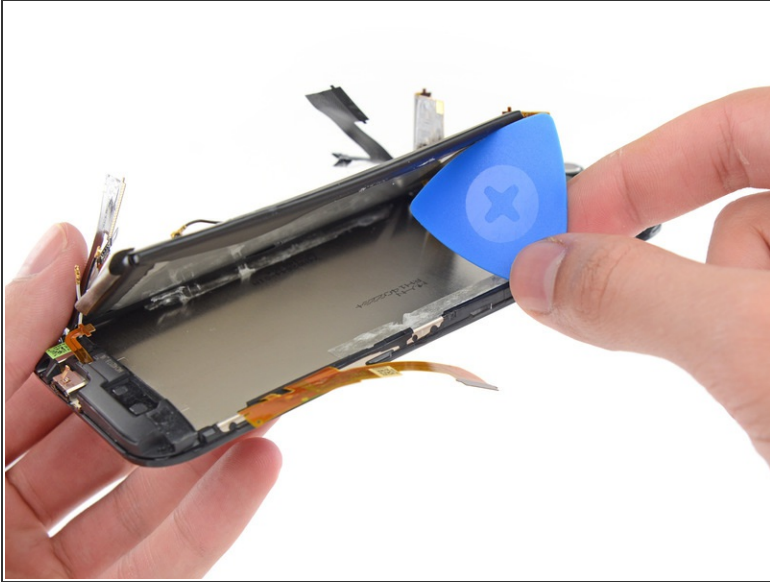
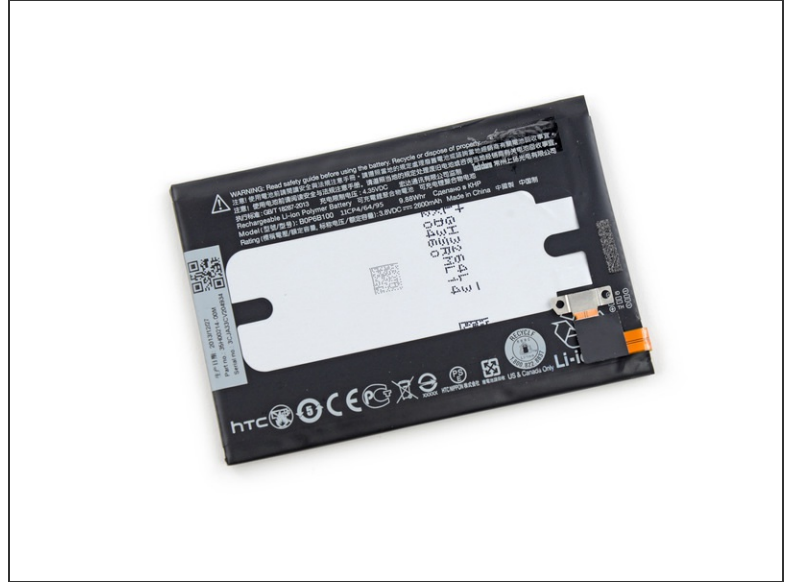
Step 11

- With the motherboard free, we turn our attention to the battery.
- You heard right: you have to remove the motherboard to get to the battery, [again](#), which is more than lightly adhered to the LCD shield.
 - ❗ This super-sized serving of adhesive is sure to be a health risk for the M8's repairability score. Too bad HTC doesn't take [a recipe from Google's book](#).
- HTC touted the all-new One's exceptional battery management, with up to 2 weeks of standby from a 100% charge, and 15 hours on 5%. Wowzers.
 - ❗ Much of this comes from low-power sensors and clever software, plus a 2600 mAh battery, up 300 mAh [from last year](#).

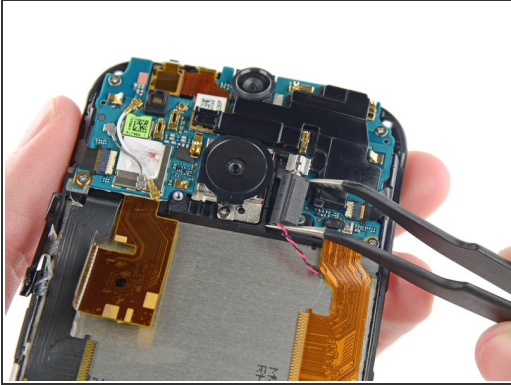
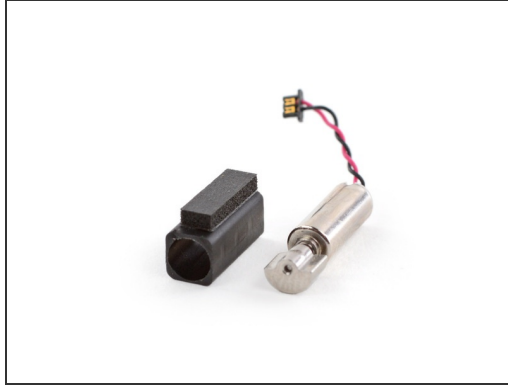
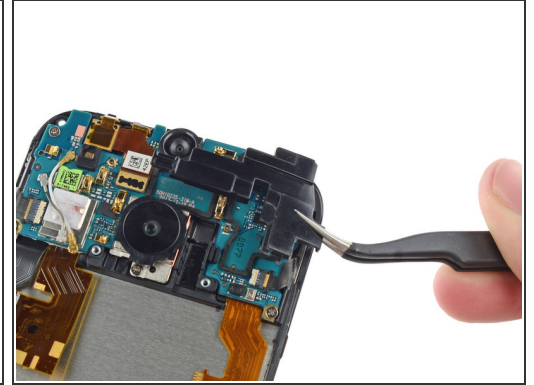
Step 12

- Time for a couple bite-sized goodies from the One:
- The rotary vibrator motor lies in this square rubber case.
- The earpiece speaker is backed by a plastic amplifying chamber, providing the required oomph for this half of the highly touted "BoomSound" stereo speakers.
- With the speaker chamber removed, we're cleared for take-off to get this daughterboard off the ground case.

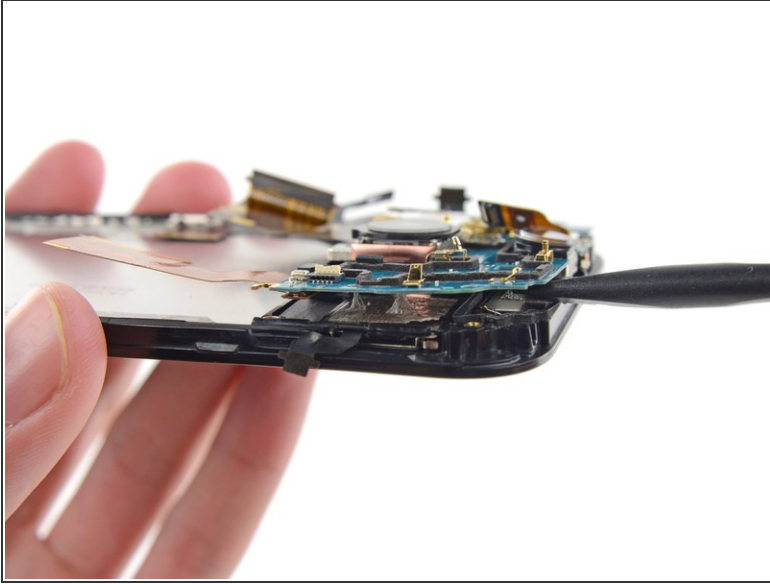
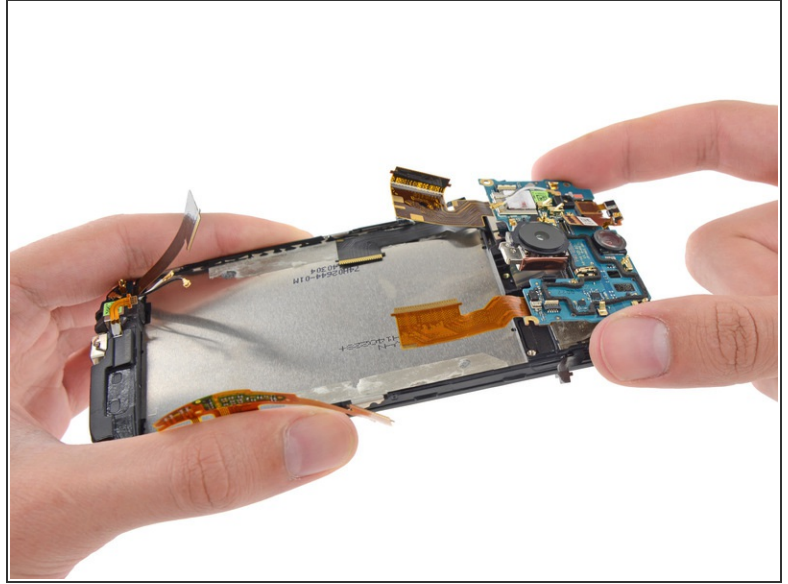
Step 13

- Or at least we thought we were, until we found the glue holding the board in place.
 - Our [will](#) spudger is strong, but our spudgering arm is getting mighty tired.
- With the daughterboard free, it's time to gather 'round for a peek at the fancy camera tech.

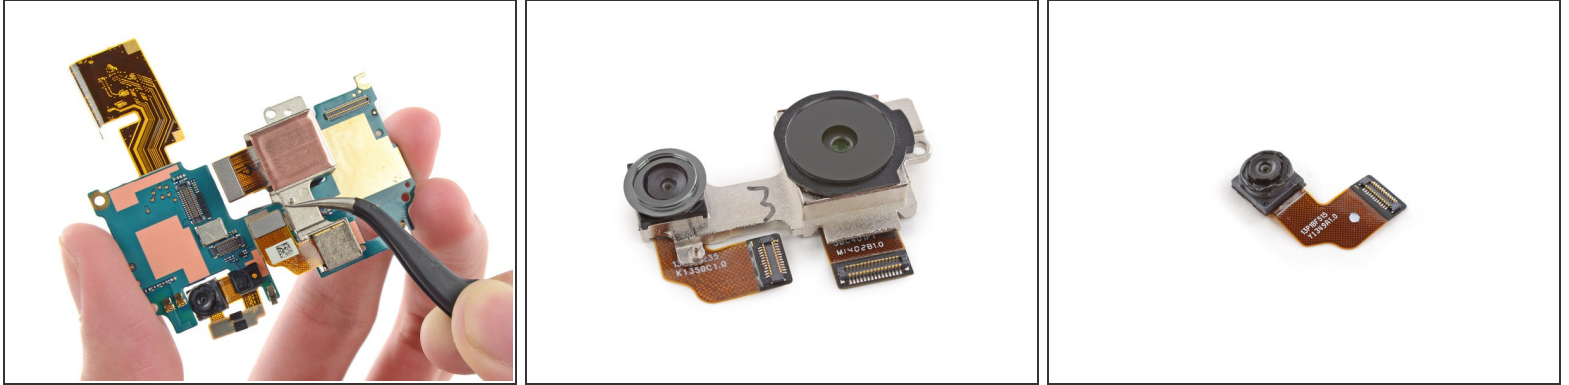
Step 14

- Chipworks found [last year's "UltraPixel" cam](#) to be a 4-megapixel affair. This revision likely has the same pixel count, but with larger pixels.
- Much more interesting is the addition of this secondary rear camera, which in concert with the first enables all sorts of fancy image data manipulation, retroactive focusing, and special effects.
- Not to be outdone, the intrepid selfie-cam gets a huge spec bump, leaping from last season's [2.1 megapixels](#) to a whopping 5.0 MP (more than selfiesufficient).

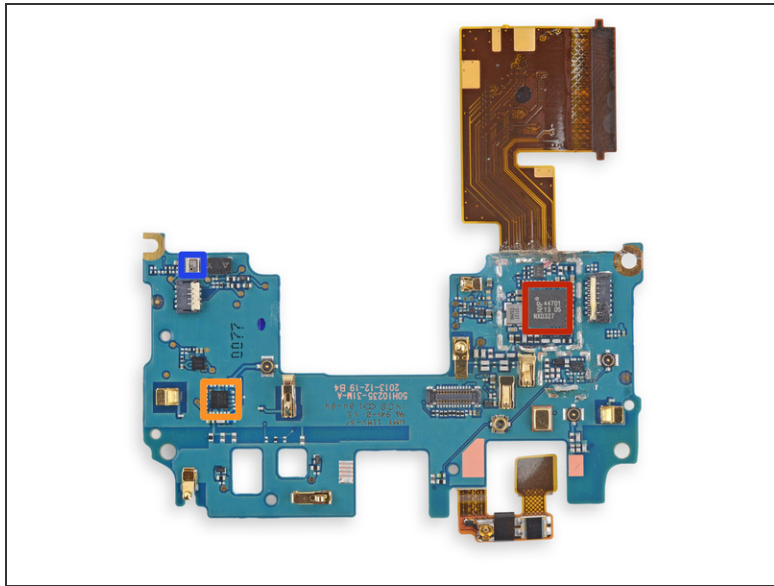
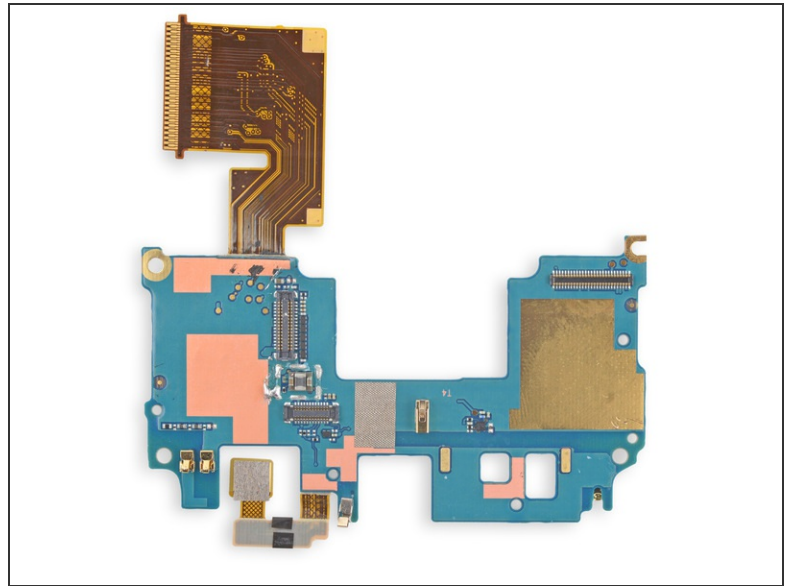
Step 15

- Keeping each other company on the now-sparsely-populated daughterboard are a couple of remaining chips:
 - NXP [44701](#) NFC controller
 - Bosch Sensortec BMP280 pressure sensor
 - Qualcomm [QFE1550](#) dynamic antenna matching tuner

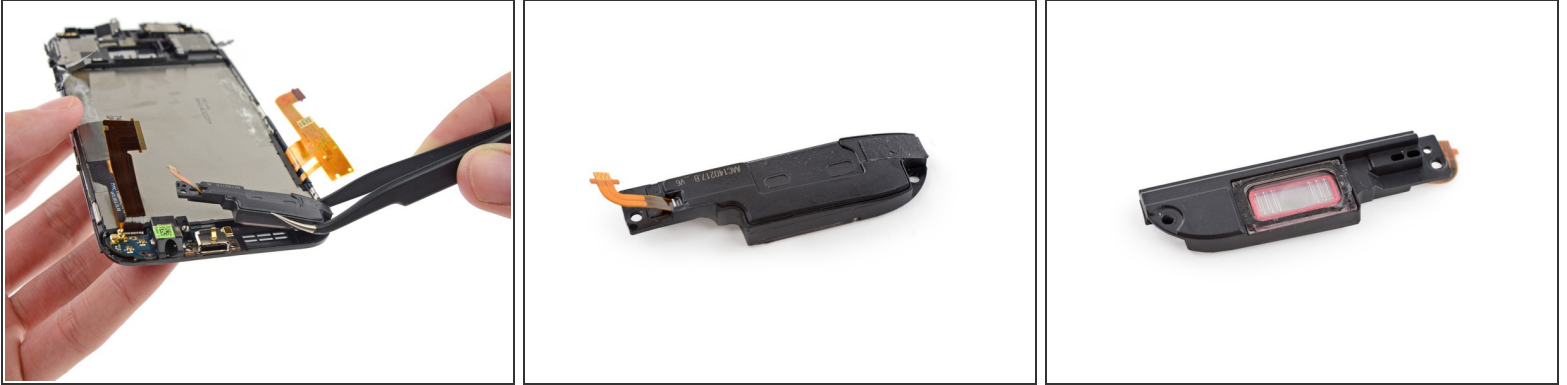
Step 16

- A tap of our tweezers and we step into ~~speakeasy~~ speaker action.
- Dr. Dre fans, beat your chests in sorrow: HTC's partnership with Beats Audio has ended. Despite this, early reviews confirm the speakers are quite good... for a phone.
- These HTC BoomSound speakers give some good vibrations, rated up to 95dB, or [just shy of a pneumatic drill.](#)

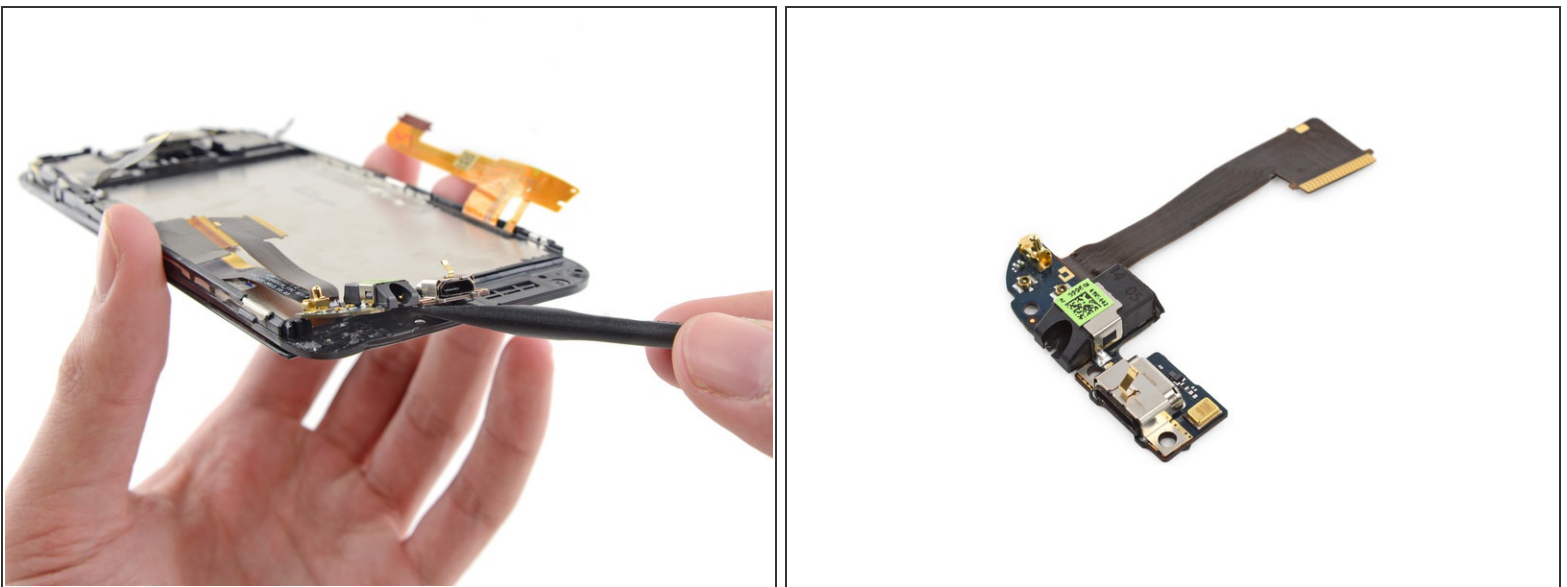
Step 17

- Last to leave the party is the 3.5 mm audio jack, now sharing a small cable assembly with the microphone and micro-USB port on the bottom of the phone.
- We give it a gentle nudge out the door with the spudger. [The end is in sight...](#)

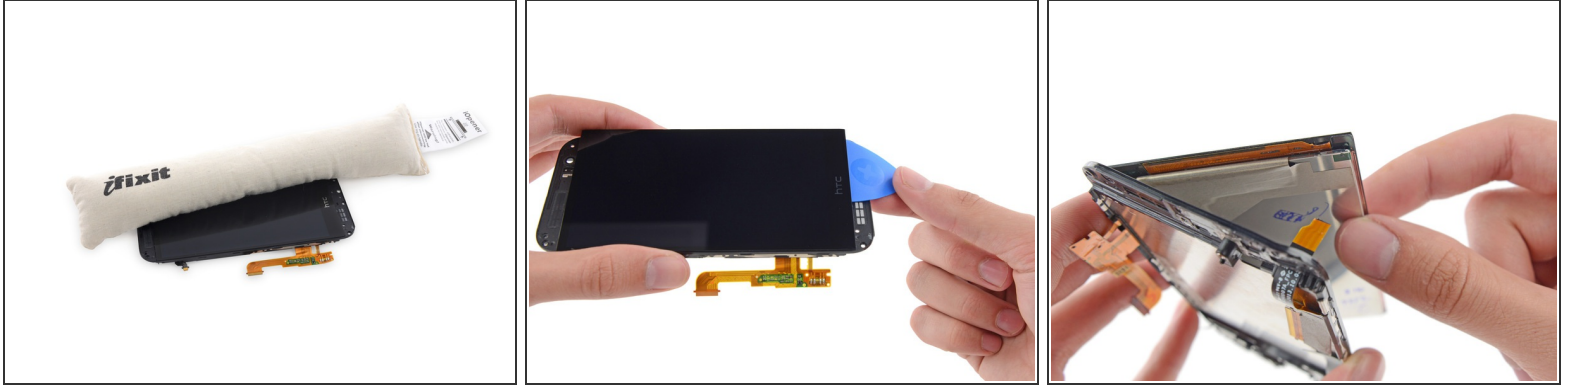
Step 18

- With the front panel mostly stripped down, we finally get to display removal.
 - ① "Finally" because we've gotten accustomed to Apple's [display-out-first iPhone assembly](#)—which greatly simplifies display repairs—so we're not sure why some manufacturers insist on burying both the screen and the battery. At least make one easy to replace!
- Liberal heat around the edges of the glass and we're able to easily slide an opening pick around the perimeter, separating the adhesive.
 - ...A little too easily, in fact, as we discovered the exact **wrong place** to slice and dice, severing the digitizer cable.
- ① Feel free to thank us for our noble sacrifice, breaking our phone so you don't have to.

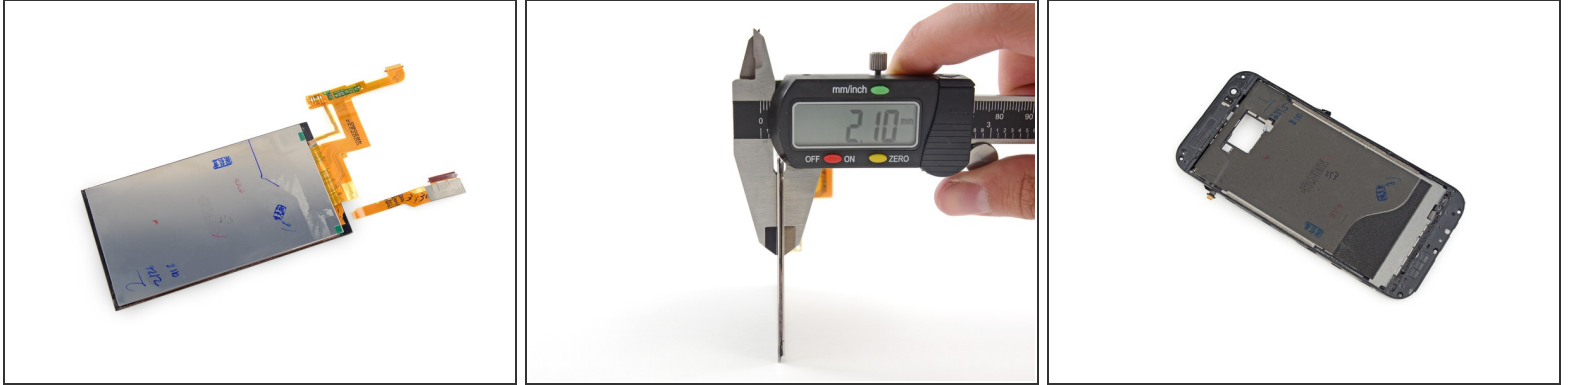
Step 19

- ① What a trial, to remove and replace the screen. Luckily HTC acknowledges the difficulty and provides [one free screen replacement](#) on your new M8 (in the first six months). Don't break it after that.
- With all of the quality control stamps and signatures on the back of the 1080p display, we're reminded of a certain [Macintosh](#) we recently tore down.
- To make a thin phone (9.4 mm), you need thin components. The fused LCD and digitizer measures little more than 2 mm.
- Down to a bare midframe, it's time for the teardown team to high-five, have a beer, and mull over the storm of a repairability score to come.
- ① Spoiler alert: it's going to look a lot like [this One](#).

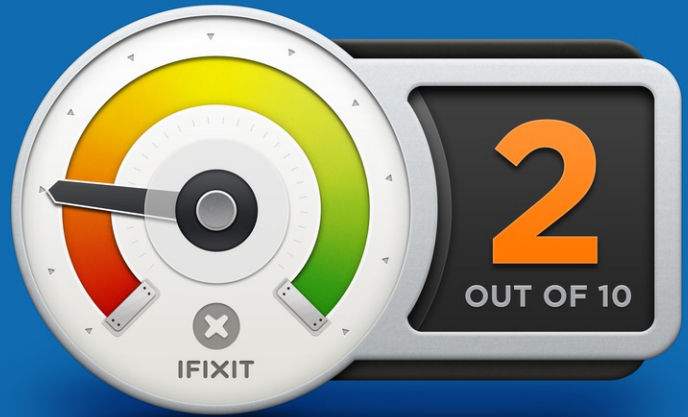
REPAIRABILITY SCORE:

- HTC One M8 Repairability Score: **2 out of 10** (10 is easiest to repair)
 - It's very difficult—although no longer impossible—to open the device without damaging the rear case. This makes every component extremely difficult to replace.
 - The battery is buried beneath the motherboard and adhered to the midframe, hindering its replacement.
 - The display assembly cannot be replaced without tunneling through the entire phone. This makes one of most common repairs, a damaged screen, very difficult to accomplish.
 - Copious amounts of tape, adhesive, and copper shielding make many components difficult to remove and replace.
 - Solid external construction improves durability.
